# Manhole Inspection Summary

Manhole # S13G1\_018MH

**Location** Address: **3204 Stanley Rd** Cross Street: **W Patapsco Ave**

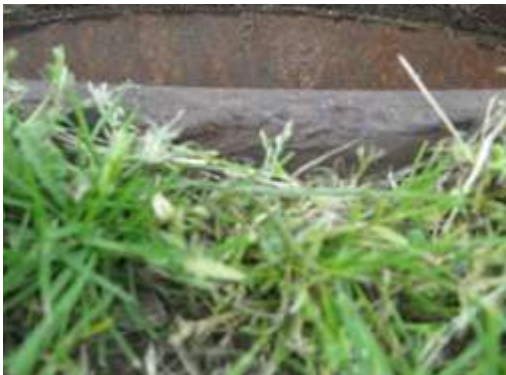
**Cover** Shape: **Circular** Diameter: **26** (in.) Length: **0** (in.) Dist A/B Grade: **1** (in.)

a/b grade 1inch

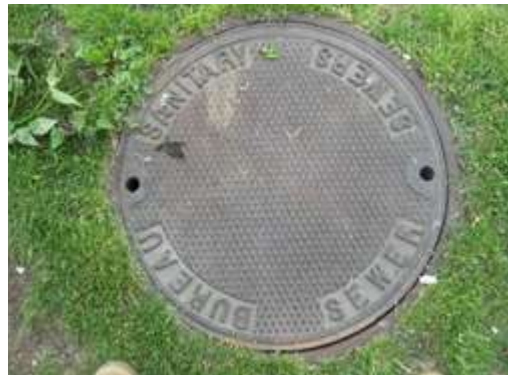
Cover View

Type: **Sanitary** Condition: **Worn** Cover Material: **Cast Iron**

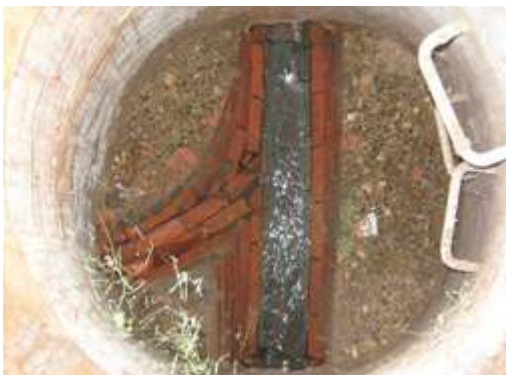
misc-1

bench debris

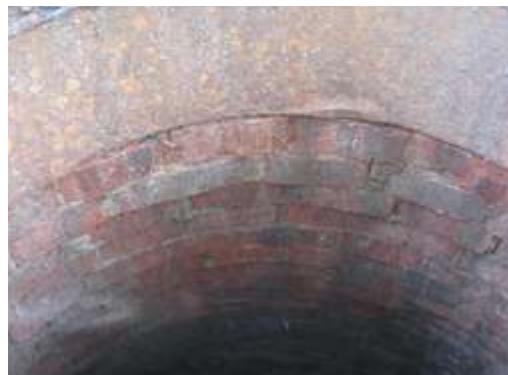
Defect 2

**Frame** Offset: **0** (in.) Condition: ☐ Sound ☐ Cracked ☒ **Leaks**

signs of infiltration from frame-cover

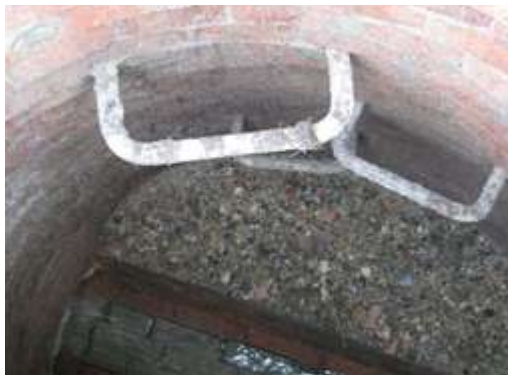
### Defect 1

**Steps** Count: **3** Missing: **0** ☒ **Corroded**

oxidized rungs

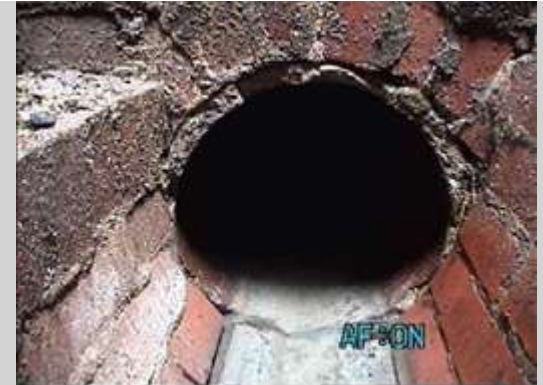
12 O'Clock Outflow

12 in. Circular Gravity Sewer  
Pipe Out @ 12 O'Clock

Pipe Height: **12** (in.) Rod and Bar (Angled)  
Pipe Material: **Clay** ☐ Pipe Lined  
Invert Depth: **7.55** (ft.) Flow Characteristics: **Slow**  
Deposits: ☒ None ☐ Mud ☐ Sludge ☐ Debris ☐ Grease  
Silt Depth: **0** (in.) Deposits Extent:  
Infiltration: **None** Pipe Seal Cond: **Sound**

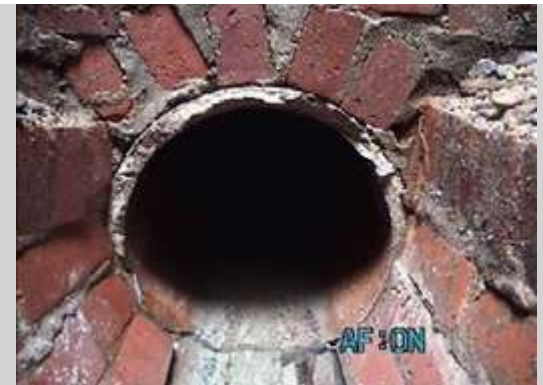
6 O'Clock Inflow

12 in. Circular Gravity Sewer  
Pipe In @ 6 O'Clock

Pipe Height: **12** (in.) Rod and Bar (Angled)  
Pipe Material: **Clay** ☐ Pipe Lined  
Invert Depth: **7.45** (ft.) Flow Characteristics: **Slow**  
Deposits: ☒ None ☐ Mud ☐ Sludge ☐ Debris ☐ Grease  
Silt Depth: **0** (in.) Deposits Extent:  
Infiltration: **None** Pipe Seal Cond: **Sound**

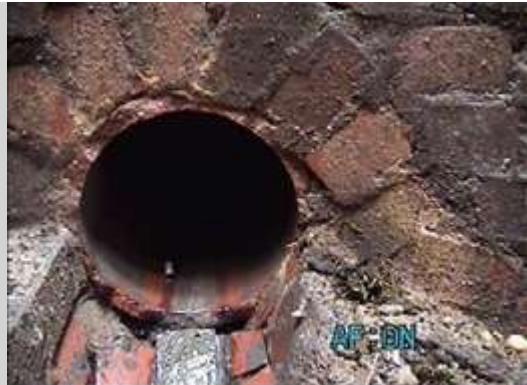
8 O'Clock Inflow

8 in. Circular Gravity Sewer  
Pipe In @ 8 O'Clock

Infiltration: **None** Pipe Seal Cond: **Unknown**
